# RESERVE ANALYSIS REPORT

**Ponderosa Ridge Homeowners Association**

Spokane, Washington

Monday, October 07, 2019

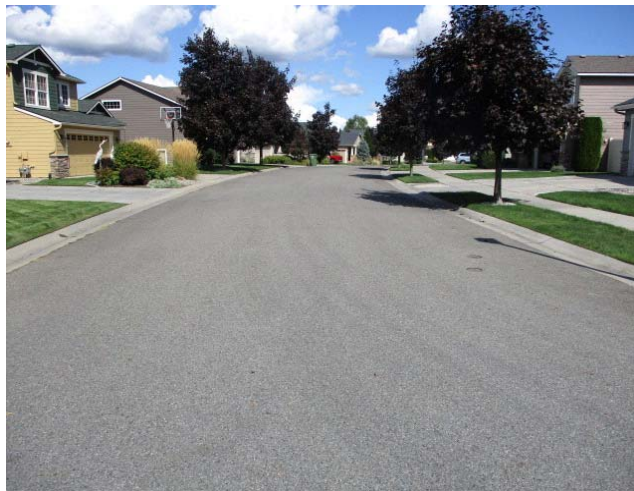
This is for the asphalt streets that were constructed between 2003 - 2004. These streets include, N. Sundance Ln, N Madeline Ln, N. Torrey Ln, W. Juniper Ln and a portion of N. Rosebury Ln.

78,303 - sq. ft. of asphalt overlay	@	\$1.50	=	\$117,454.50
17 - manhole covers	@	\$340.00	=	\$5,780.00
9 - valve covers	@	\$125.00	=	\$1,125.00
		<b>TOTAL</b>	<b>=</b>	<b>\$124,359.50</b>

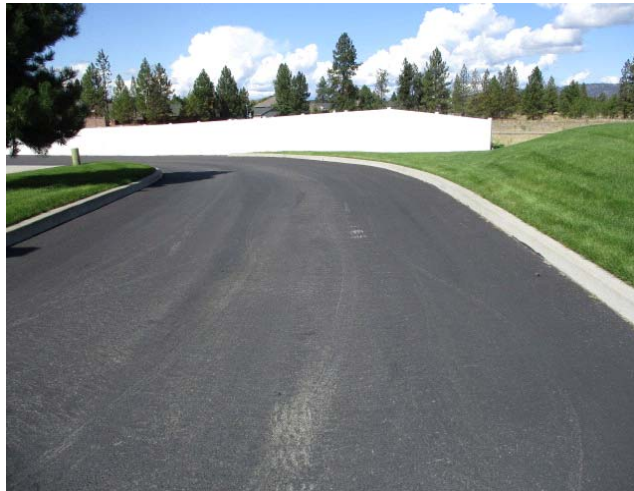
This is for the asphalt streets that were constructed between 2007, 2009 & 2010. These streets include, N. Barnes Rd and a portion of N. Rosebury Ln.

75,938 - sq. ft. of asphalt overlay	@	\$1.50	=	\$113,907.00
12 - manhole cover	@	\$340.00	=	\$4,080.00
23 - valve cover	@	\$125.00	=	\$2,875.00
		<b>TOTAL</b>	<b>=</b>	<u>\$120,862.00</u>

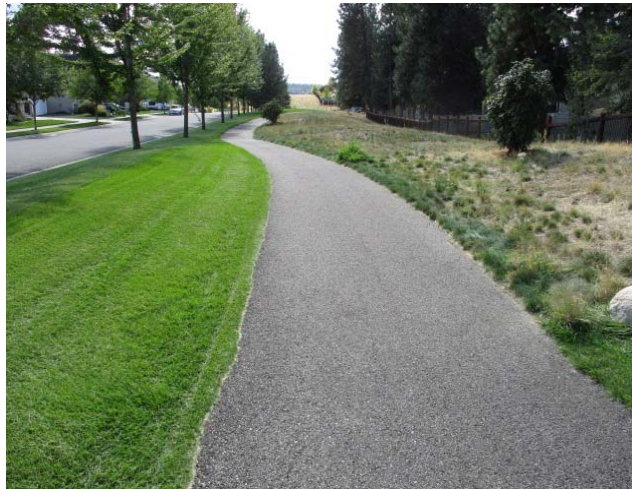
This is for the asphalt bike path located along Creston Ln.

6,984 - sq. ft. of asphalt overlay	@	\$1.50	=	\$10,476.00
		TOTAL	=	\$10,476.00

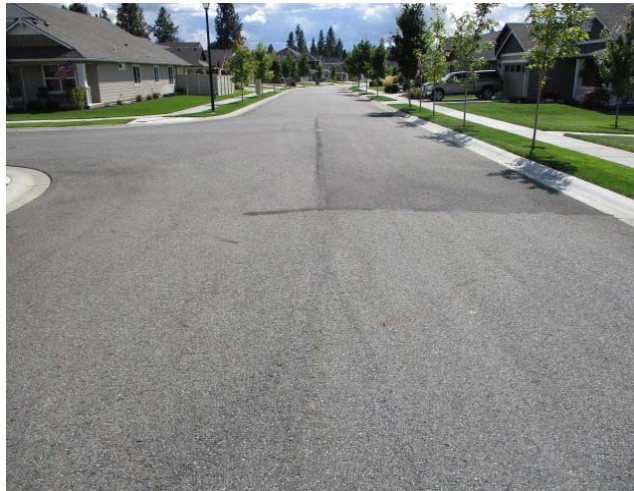
#### Streets - Asphalt, Repairs

It is estimated that a percentage of the asphalt areas will require repair or replacement. The actual condition of the asphalt should be monitored through time and these estimates adjusted accordingly.

We have budgeted for the asphalt to be repaired on the same cycle and in conjunction with the seal coating of the asphalt.

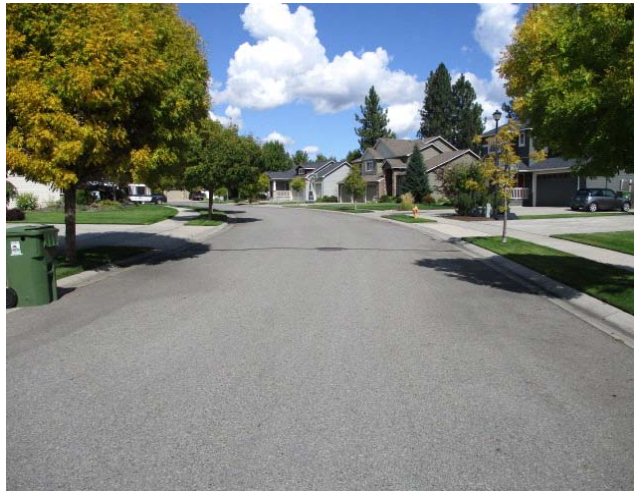
Asphalt surfaces should be seal coated within 5 years of their initial installation. Thereafter, a 3 to 5 year cycle should be observed and adjusted according to the client's particular needs.

The remaining life of the asphalt seal coating has been adjusted to align with the future replacement cycles of the asphalt overlay.

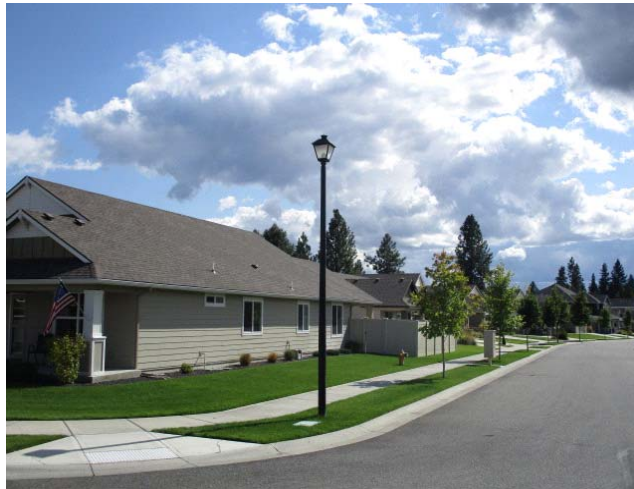
These are the street lights located throughout the community:

31 - street lights	@	\$1,500.00	=	\$46,500.00
		TOTAL	=	\$46,500.00

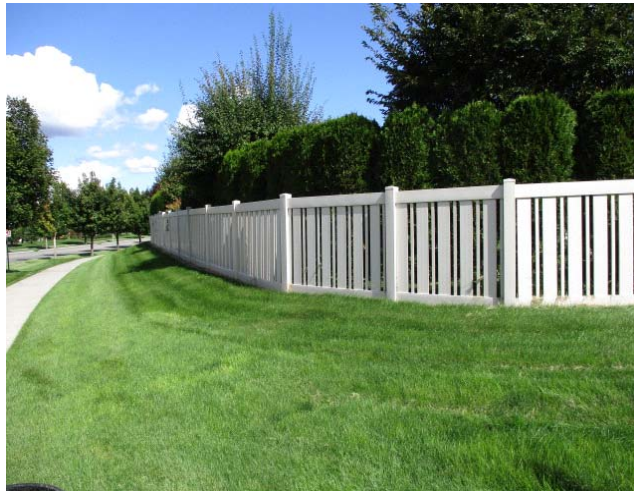
This is the vinyl privacy fencing located along the SE side of North Barnes Rd:

705 - lin. ft. of 5ft. Fence	@	\$40.00	=	\$28,200.00
		TOTAL	=	\$28,200.00

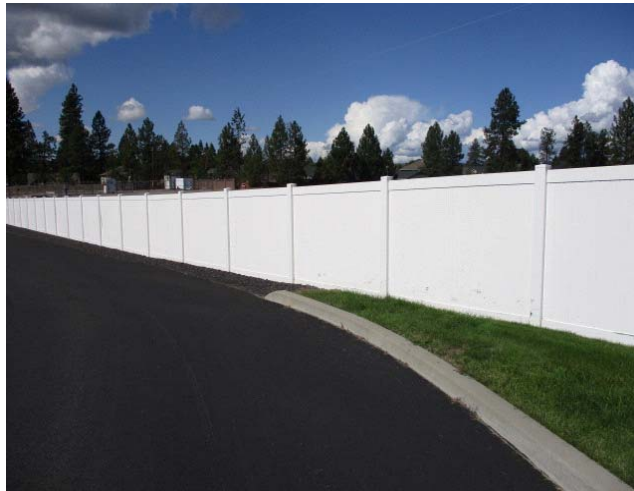
This is the vinyl privacy fencing located to the North of North Barnes Rd:

$$\begin{array}{rclcl}
 380 & \text{- lin. ft. of 6ft. fence} & @ & \$40.00 & = & \underline{\$15,200.00} \\
 & & & \text{TOTAL} & = & \underline{\$15,200.00}
 \end{array}$$

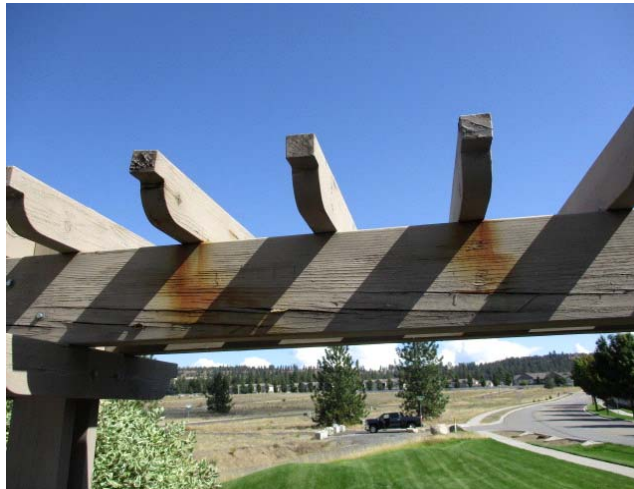
This is for refurbishing the entry monument located along W. Barnes Rd:

1 - entry monument - refurbish	@	\$1,500.00	=	\$1,500.00
		TOTAL	=	\$1,500.00

This provision includes painting, wood structural and masonry repairs.

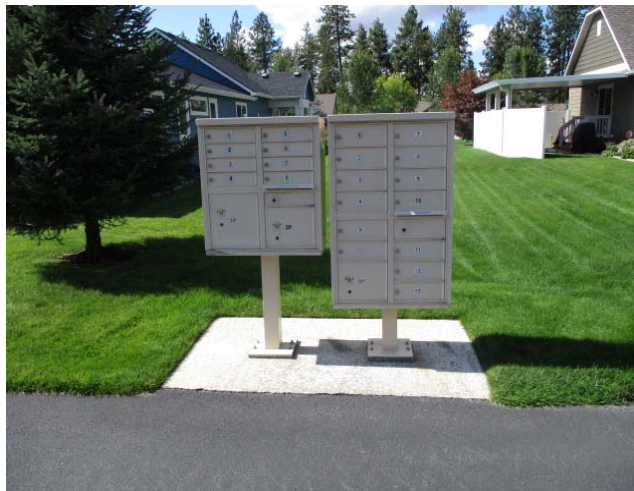
These are the pedestal metal mailbox sets located throughout the community:

10 - 16 box units	@	\$1,400.00	=	\$14,000.00
3 - 13 box units	@	\$1,250.00	=	\$3,750.00
2 - 12 box units	@	\$1,250.00	=	\$2,500.00
1 - 8 box units	@	\$1,150.00	=	\$1,150.00
		TOTAL	=	\$21,400.00

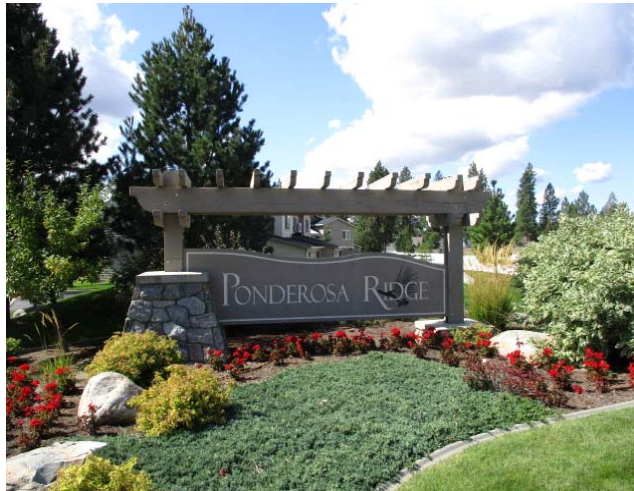
These are the various signs located throughout the community:

22 - street signs	@	\$245.00	=	\$5,390.00
2 - information signs	@	\$245.00	=	\$490.00
		TOTAL	=	\$5,880.00

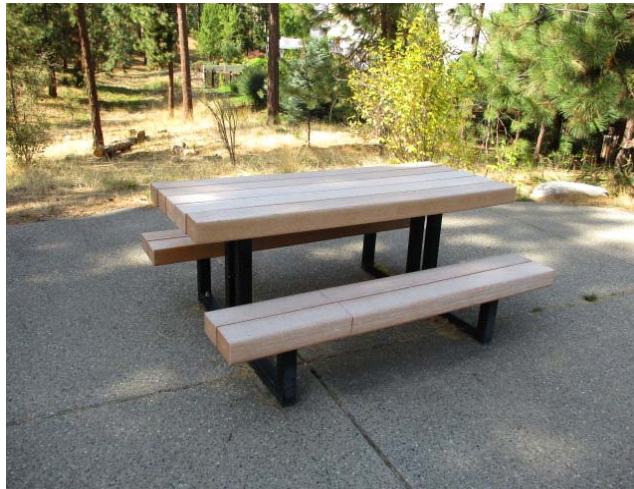
These are the site furnishings located throughout the community:

2 - park benches	@	\$475.00	=	\$950.00
1 - picnic tables	@	\$575.00	=	\$575.00
		TOTAL	=	\$1,525.00

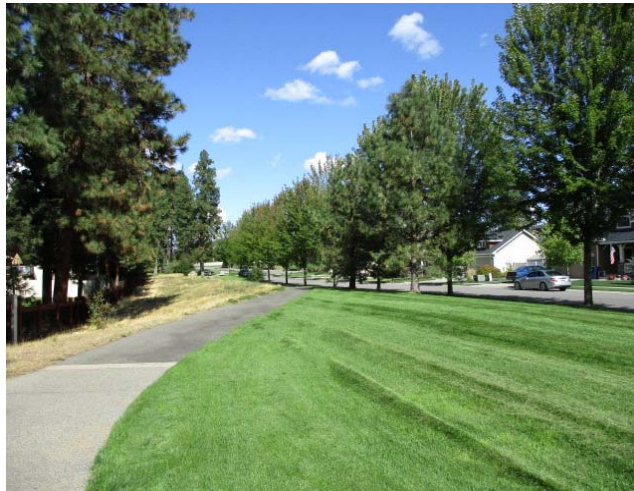
This is for refurbishing of the landscape areas located throughout the community.

This includes, but is not limited to tree replacement, shrubbery, landscape bark and landscape rock.

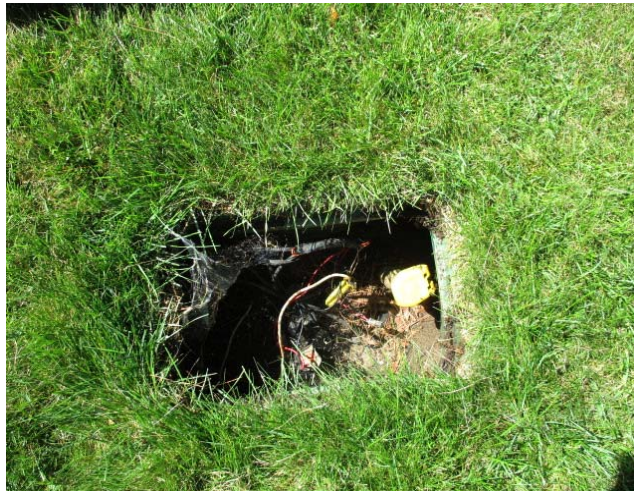
For the purposes of this analysis, we have budgeted for this equipment using general estimates based on our experience with similar equipment.

This is the irrigation system. This includes, but is not limited to irrigation controllers, cabinets (if present), backflow valves, drainage installations and infrastructure maintenance.

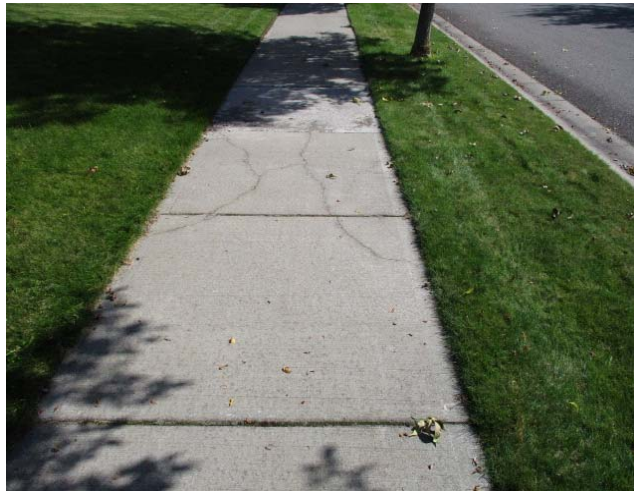
Please refer to our comments in the Consultant's Disclosure regarding unfunded components.

These are the typical sidewalks, curbs, and drainage swales located throughout the community.
